Roller Testing to Mimic Damage of the ISS SARJ Ring and Durability Test to Simulate 15 Years of SARJ Operation Using the Damaged Surface

*Timothy L. Krantz, Justin P. Elchert, Christopher DellaCorte, and Michael J. Dube
Glenn Research Center, Cleveland, Ohio*

Glenn Research Center
Cleveland, Ohio 44135

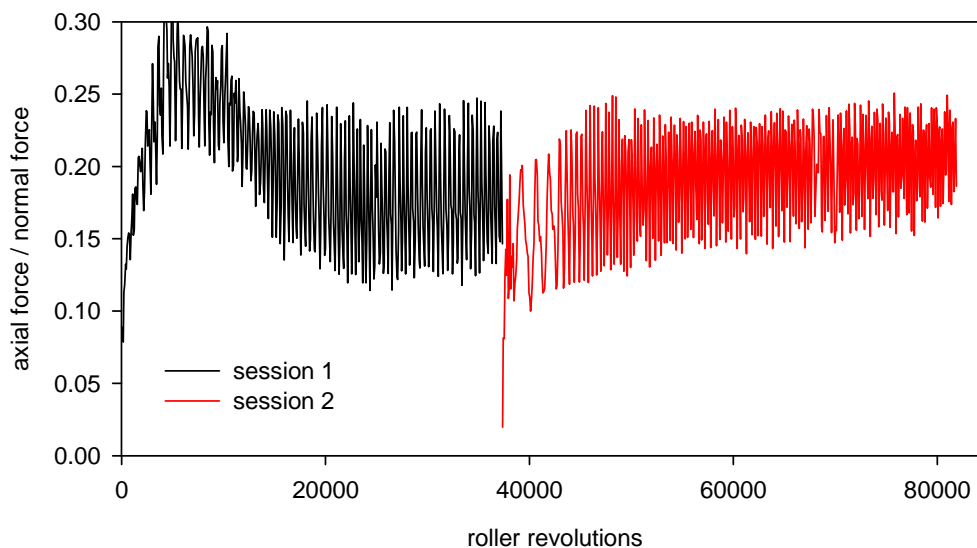
Figure 51.—Trend of thrust load to normal load ratio during testing interval #4 comprising 81,887 roller revolutions.

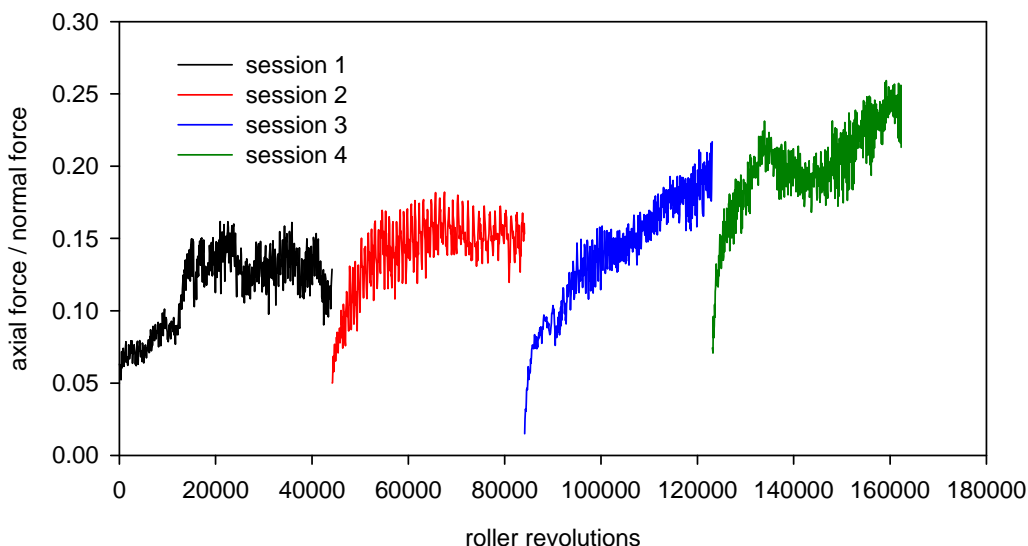
Figure 52.—Trend of thrust load to normal load ratio during testing interval #11 comprising 162,345 roller revolutions.

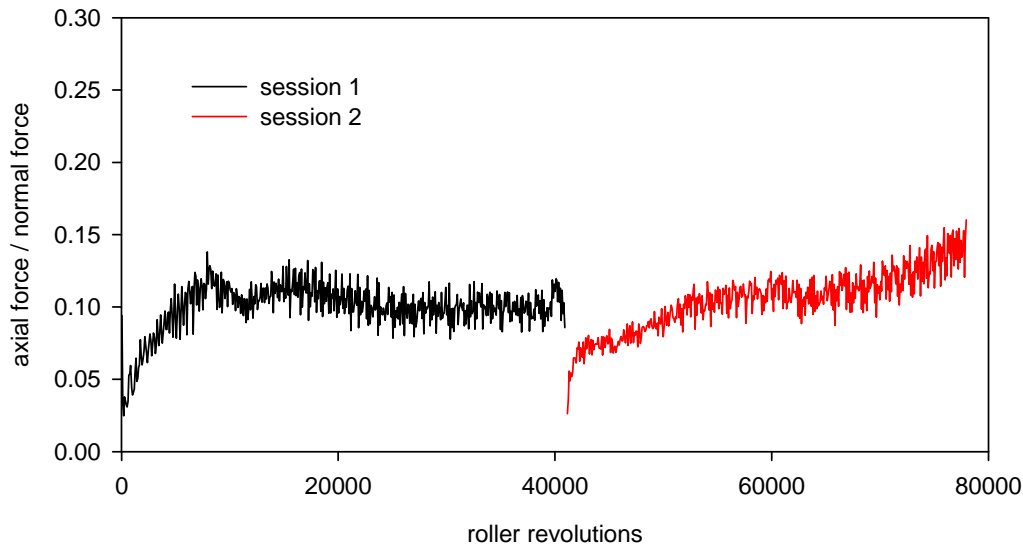
Figure 53.—Trend of thrust load to normal load ratio during testing interval #16 comprising 78,000 roller revolutions.

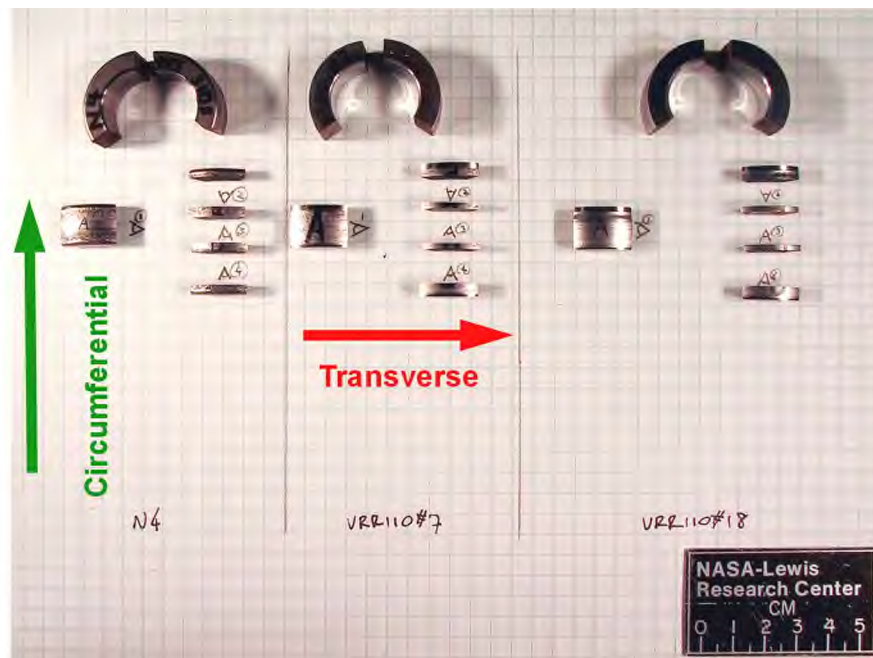
Figure 54.—Pieces created by sectioning of tested rollers for metallography inspections.

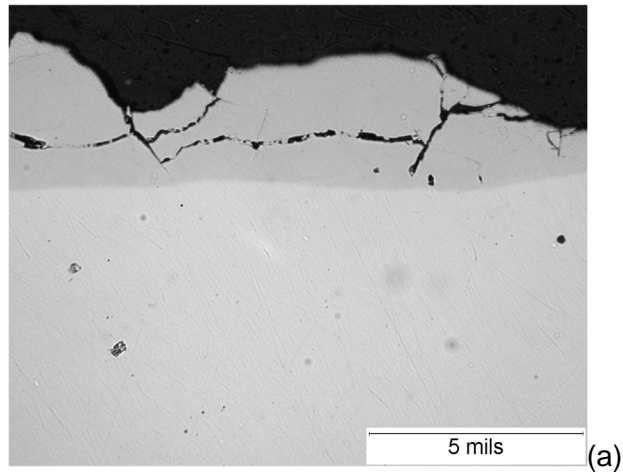
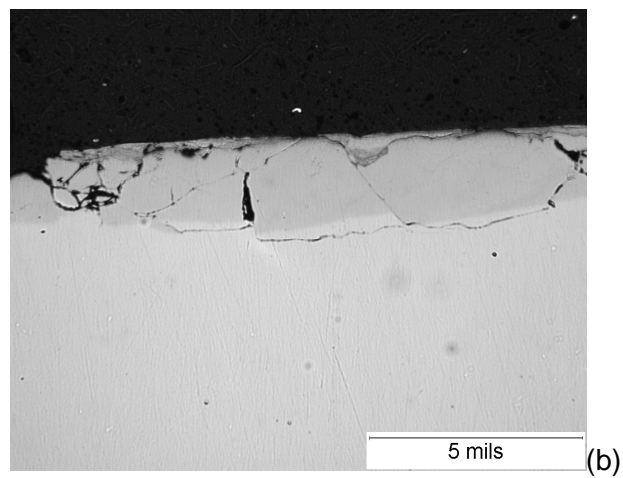
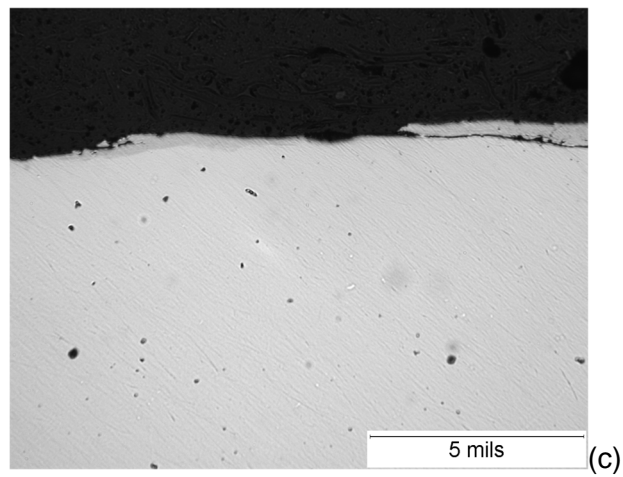
Figure 56.—Section views of the nitrided 15-5 roller, circumferential views (rolling direction within plane of page). (a) Location 3 mm from edge closest to fastening nut. (b) Location 3 mm from edge closest to shaft shoulder. (c) Location near middle of roller.

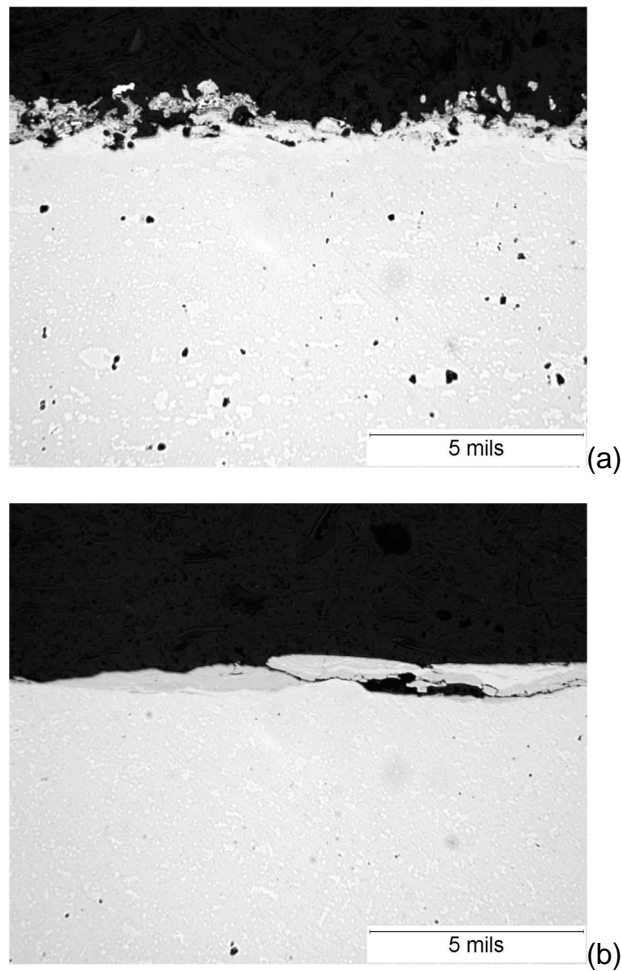
Figure 57.—Section views of the 440C roller. (a) Transverse view, rolling direction perpendicular to page. (b) Circumferential view.
